# **Chapmanville Intermediate School** in Logan County

TERRADON Corporation performed a visual site evaluation of work performed to date at the Chapmanville Intermediate School site on August 10th, 2018. Overall the site was fairly dirty with soiled pavements, seeded lawn areas were partially established and erosion observed was minimal. The following bullet points are issues identified through visual observations and are considered deficiencies that should be addressed (this review is not all-inclusive and all work is subject to conform to plans & specifications):

A representative of Harper Engineering visited the site on Wednesday, August 15, 2018. The following items were noted.

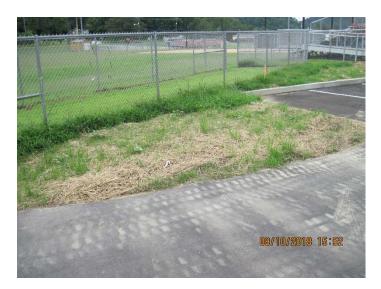
- Lawn areas of project need to be weeded, rocks and clumps of dirty larger than ½" should be removed, further fine grading should be selectively performed in areas to smooth rough appearance and tire tracks, lawn should be mowed and maintained at a height of 2-3" until 60 days from date of substantial completion, and bare areas should be overseeded and mulched until lawn is fully established. It is also noted that some construction debris still remains in areas of lawn such as brick. It is particularly noted that the bus loop & parent loop island areas needs more attention, additional fine grading at the service area entrance to smooth rough areas and tire ruts, and additional tire rutting on west side of school in lawn area. See pictures 1-6.

Picture -1: Photo of lawn area not fully established.

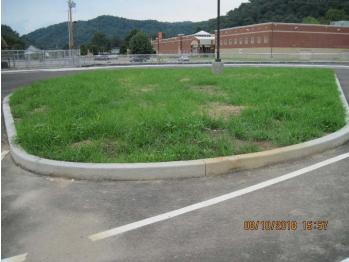
Picture – 4: Photo of bus loop island w/ bare areas & requiring mowing.

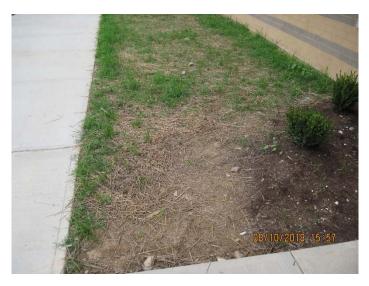
Picture – 2: Photo of bare & rocky lawn area by entrance of building.

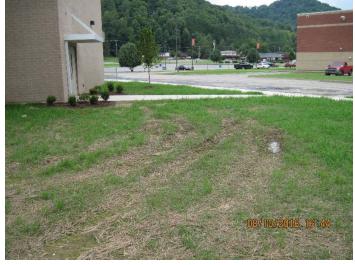
Picture – 5: Photo of tire tracks in lawn area on west side of bldg.

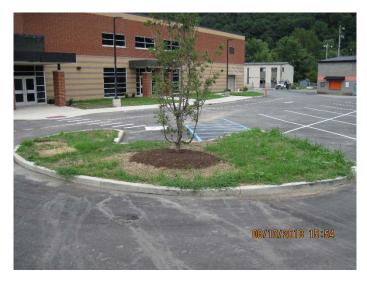
Picture -3: Photo of parent drop-off loop island with bare spots, weeds, and in generally rough condition.

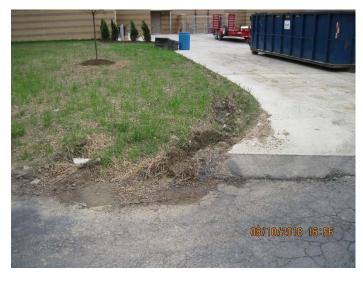
Picture -6: Photo of tire tracks & lawn area in generally rough condition at service area.

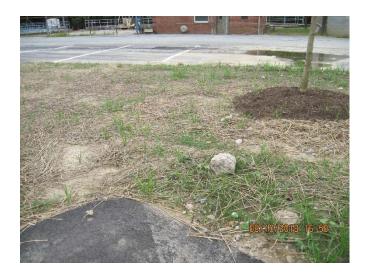
- Many landscape plantings appear to be planted too high and have not been properly backfilled with planting mix and compacted properly. It is noted that some shrubs were high and leaning and were very easily pulled out of the ground, and two shrubs were already mostly dead. It is also noted that many trees were leaning (especially in the plaza area) and were not supported and braced. See pictures 7 10.

Picture – 7: Photo of rocky lawn area not fully established.

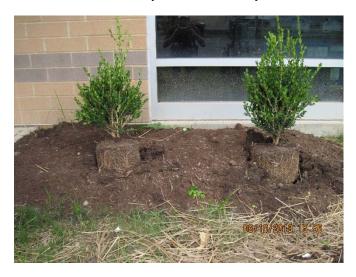
Picture -8: Photo of two shrubs which were noticed planted very high and were VERY easily lifted up by school administrators.

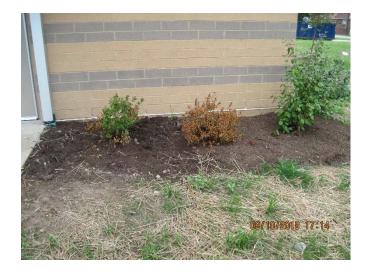
Picture – 9: Photo of one dead shrub and another which is nearly dead.

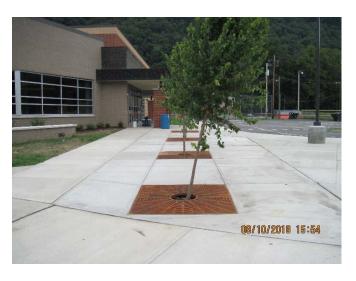
Picture – 10: Photo of a tree at the pedestrian courtyard leaning.

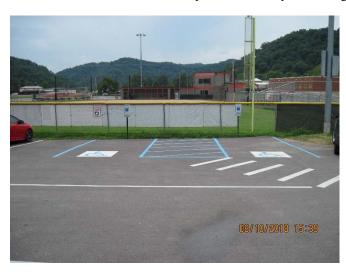
Picture -11: Photo of ADA parking spots across from elementary school which lack a sign at the loading zone.

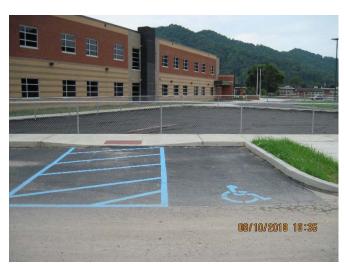
Picture -12: Photo of ADA parking & loading zone without signage & very dirty pavement.

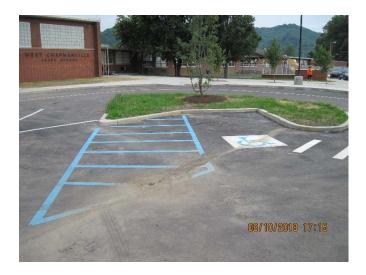
Picture – 13: Photo of ADA parking space & loading zone at parent drop-off loop lacking signage and with low area.

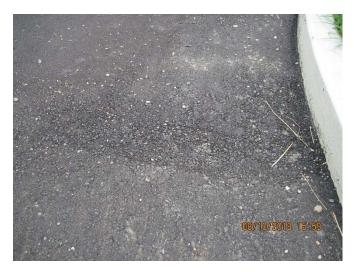
- The surface of the asphalt pavement at the bus loop generally has a rough appearance and it does not appear to have been rolled tightly enough to completely seal off surface of asphalt, there are areas of large voids in the surface similar to a base course application of asphalt. Measuring along the curbing there are areas where the curb is greater than 6" in height, many areas are 7-8" in height. I also did not notice any asphalt core tests taken and I have not seen any reports of these required core tests or density reports which should have been coordinated with Owner. It is my recommendation to have these core tests and density tests done per project specifications to check for pavement thickness and density to better determine the quality of the asphalt placed on the entire project for areas of full depth pavement. See pictures 14 15.

Picture – 14: Photo of rough wearing course pavement found at bus loop.

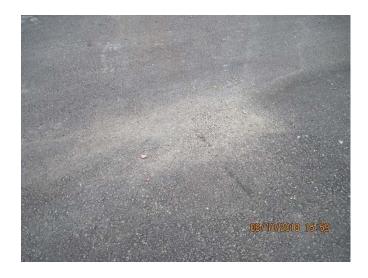
Picture – 17: Photo of low spot in pavement.

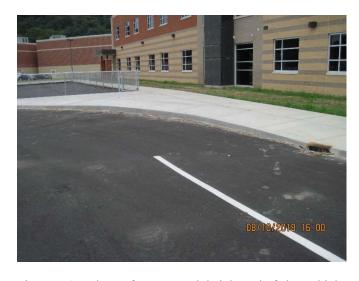
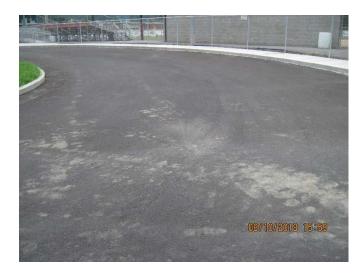
- Some sidewalk is awkward and has a hump in the triangular area adjacent to bus loop. We have asked Persinger to look into the as-built conditions to determine if the grading was followed correctly in this area. See picture 15.

Picture – 15: Photo of uneven curb height and of abrupt high spot Picture – 18: Photo of low spot & dirty new pavement. in concrete sidewalk.

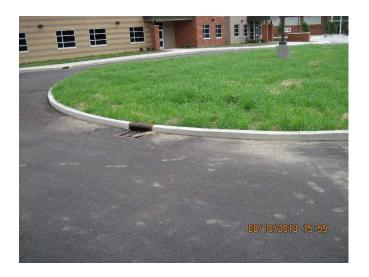
Picture – 19: Photo of low spots along curbing to CB A7..

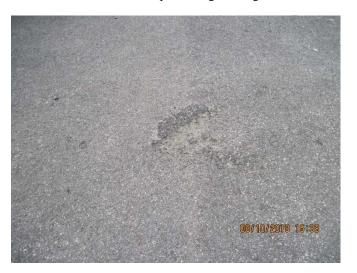
- There are many areas where the new asphalt pavement has been damaged by construction equipment and also one area where there is an unexplained 7" diameter core in pavement left open. The area of the entire project HMA pavement should be walked and any damaged areas fixed. In particular on the north end of the building in the area where there is a portion of full depth pavement in a parking area; the 7" core was noticed along with tire imprints and divots. See pictures 20 23.

Picture – 20: Photo of scrape / divot in new pavement.

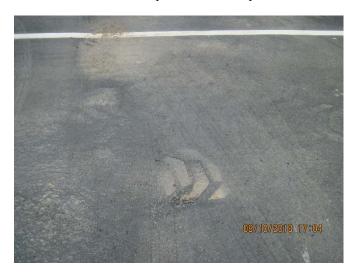
Picture – 21: Photo of tire imprint & low spot in pavement.

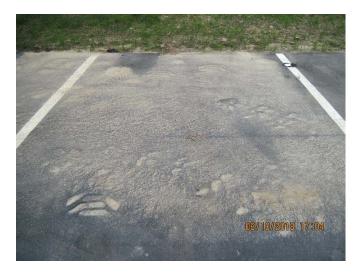
Picture – 22: Photo of tire imprints & divots in new pavement.

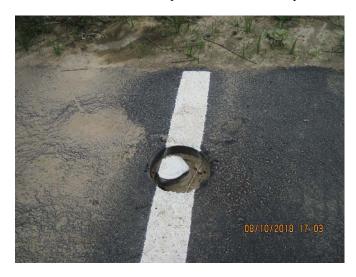
Picture – 23: Photo of 7" dia. core hole in pavement.

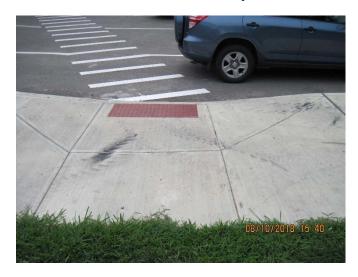
- New concrete sidewalk has significant cracking at the following locations which panels should be saw cut out and replaced with new concrete sidewalk: around the Elementary School ADA curb ramp has three cracks and a chipped portion of concrete, at the parent vehicle drop off loop on the Elementary School side there is a cracked panel adjacent to some chain link fence supplies stockpiled, adjacent to the mulched/fenced play area beside the service gate there is a cracked panel, and on the west side of the mulched/fenced play area there is a cracked panel adjacent to the parking island with connecting sidewalk. See pictures 24 26.

Picture – 24: Photo of cracked sidewalk @ ADA ramp.

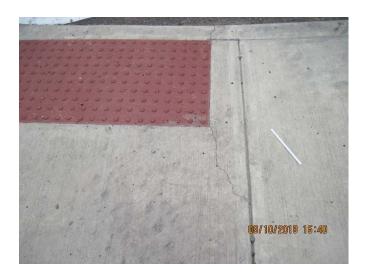
Picture – 25: Photo of cracked sidewalk @ ADA ramp.

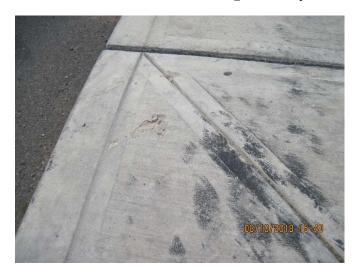
Picture – 26: Photo of chipped concrete sidewalk @ ADA ramp.

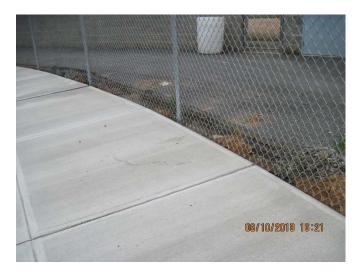
Picture – 27: Photo of gap between sidewalk & fencing which should be filled.

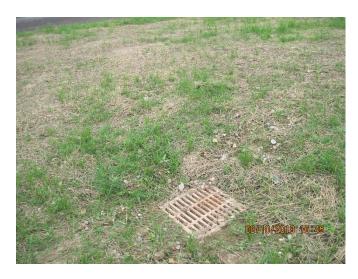
Picture – 28: Photo of area around CB B2 which is rough.

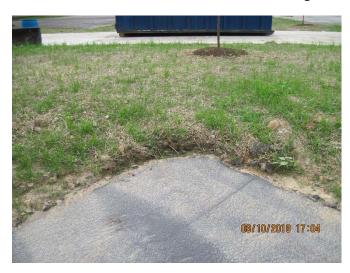
Picture -29: Photo of corner of parking space where grade is too abrupt at corner and soil should be excavated & removed.

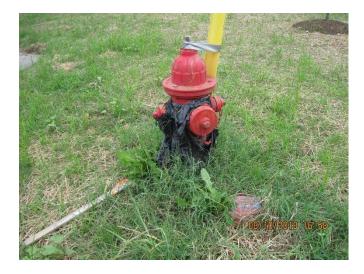
Picture -30: Photo of fire hydrant which protection can be removed and hydrant cleaned..
